Towing Vehicle - V Research Plan

Condition Survey

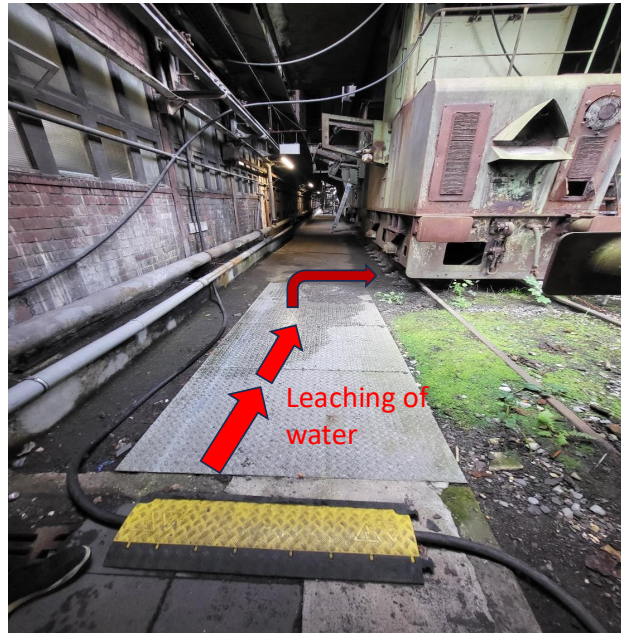
Fig 2: Water disposal way towards the towing vehicle IV and towing vehicle V. Photo captured by Sooraj Nair , October 2024

- From our visual inspection, we identified water dampness as the major contributor to corrosion in the towing vehicle, as well as to damage in the nearby masonry structure. Immediate action like repair the drainage system, improve soil drainage, redirect water flow, repoint mortar joints is required to preserve the towing vehicle V.
- Further testing has to be conducted to identify specific issues before suggesting more permanent solutions.

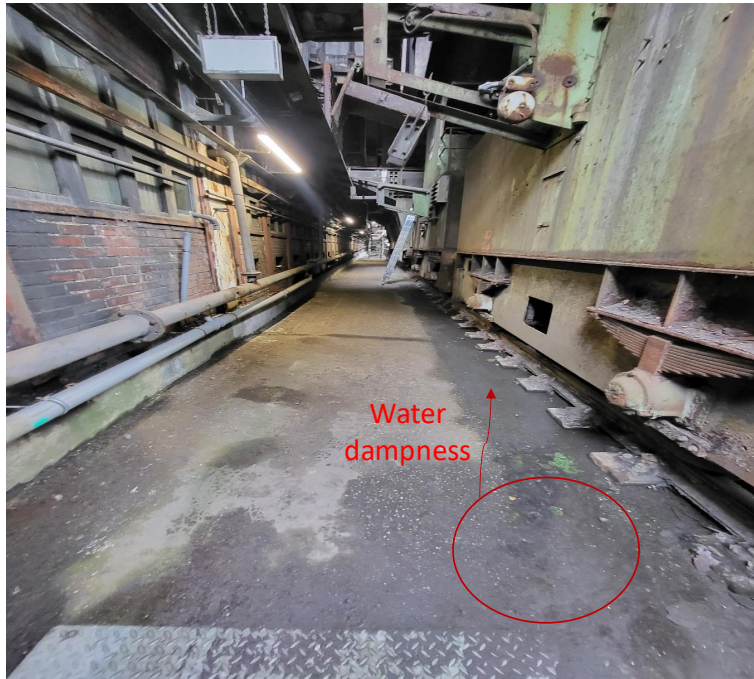
Fig 3: Water disposed around the towing vehicle IV, photo captured by Sooraj Nair, October 2024

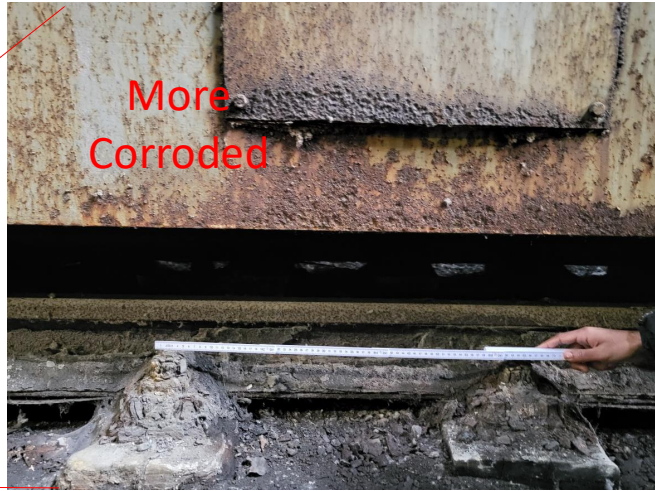
Fig 4 and 5 : The bottom part of towing vehicle - V has more corrosion, photo captured by Sooraj Nair, 2024

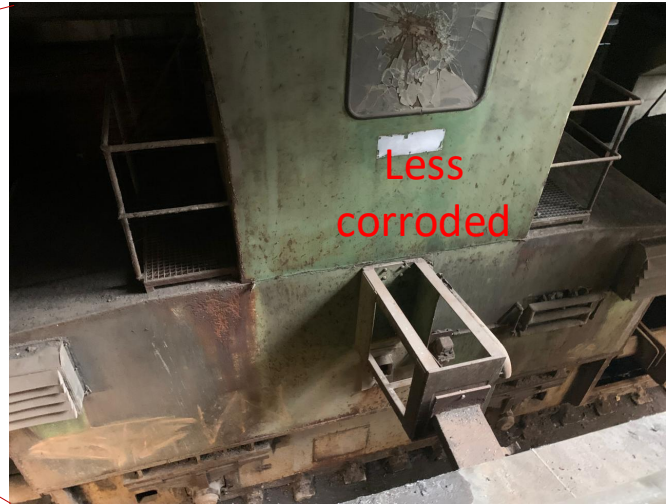
Fig 6 and 7 : The top portion of towing vehicle - V have less corrosion, photo captured by Sooraj Nair, 2024.

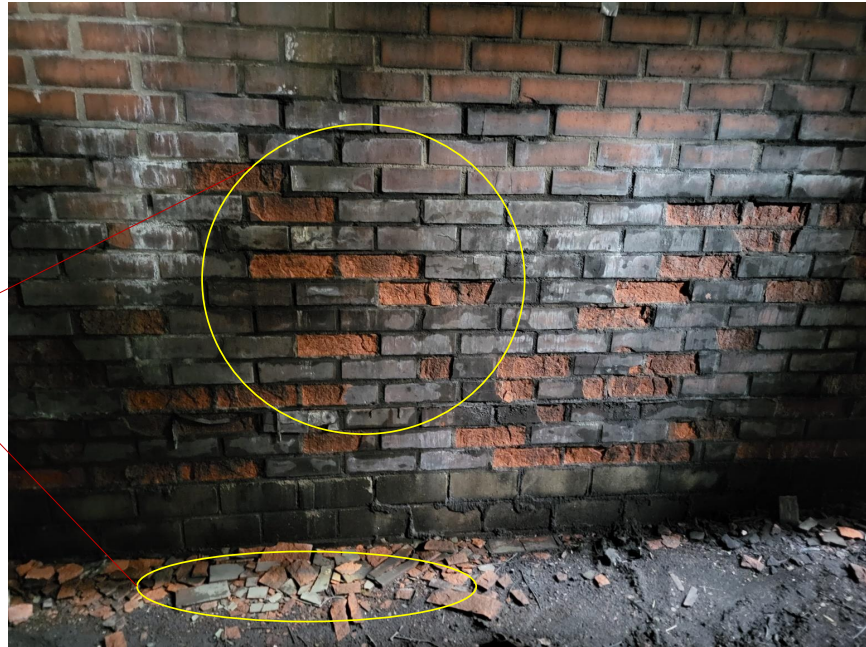
Spalling of brick

Fig 8: Bricks spall off due to water absorption on north side of towing vehicles IV and V , photo captured by Sooraj Nair, 2024.

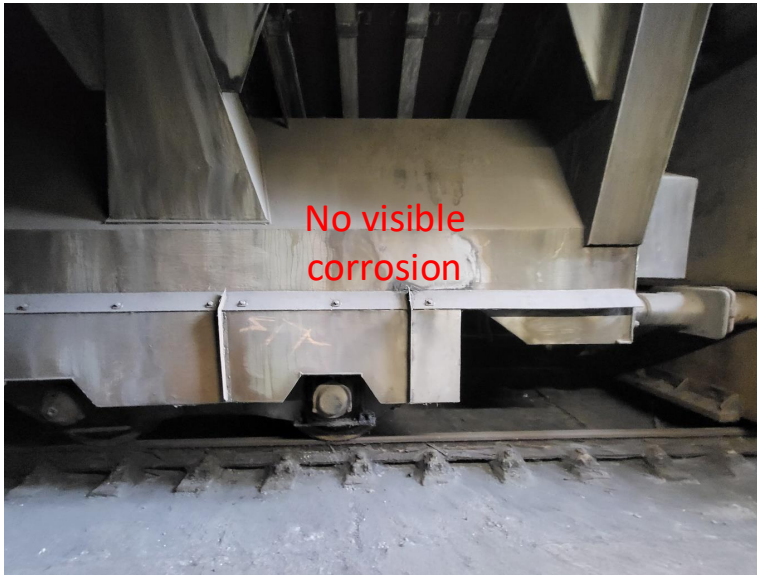
Fig 9: Bottom side of the quenching car, photo captured by Sooraj Nair, 2024.

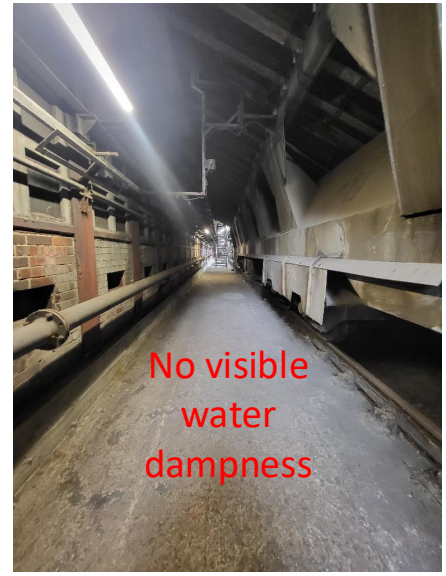
Fig 10: The floor adjacent to quenching car, photo captured by Sooraj Nair, 2024.

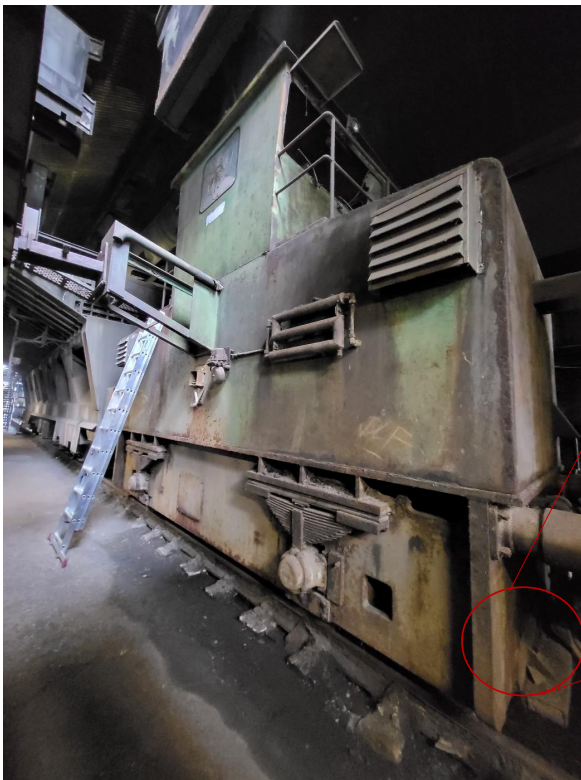
- Object : Towing vehicle V
- Location of the object : North side of coke oven batteries, coking plant Zollverein in Essen.
- Analysis : SEM for examining surface morphology, EDX for elemental composition and XRD for identifying crystalline phases of corrosion products.
- Sampling location : South side 285 cm from the base of coke oven battery wall to center of the rail. 19 cm high from the bottom edge of the rail and 34 cm high from the ground. Labeled in Figure.

Fig 13 and 14: Points to be taken for conducting SEM,XRD etc, photo captured by Sooraj Nair,October,2024.
